No. 1573

FLIGHT MEASUREMENTS OF THE FLYING QUALITIES OF
FIVE LIGHT AIRPLANES

By Paul A. Hunter

Langley Memorial Aeronautical Laboratory
Langley Field, Va.

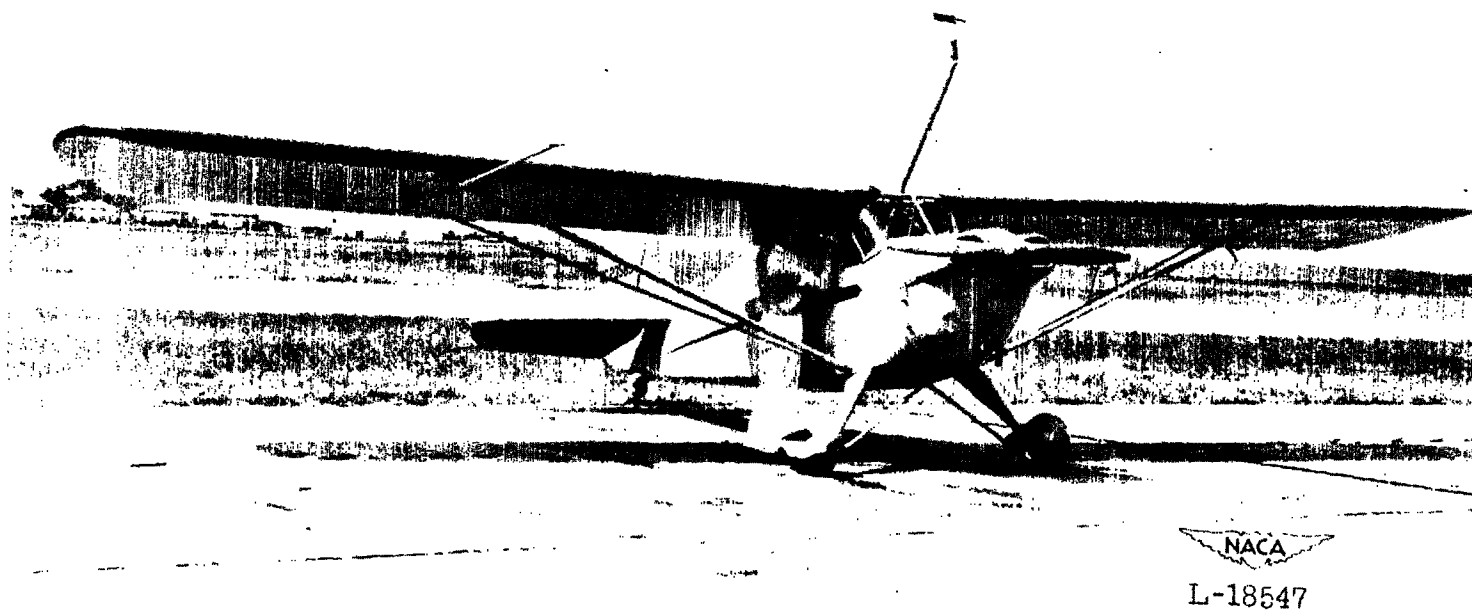
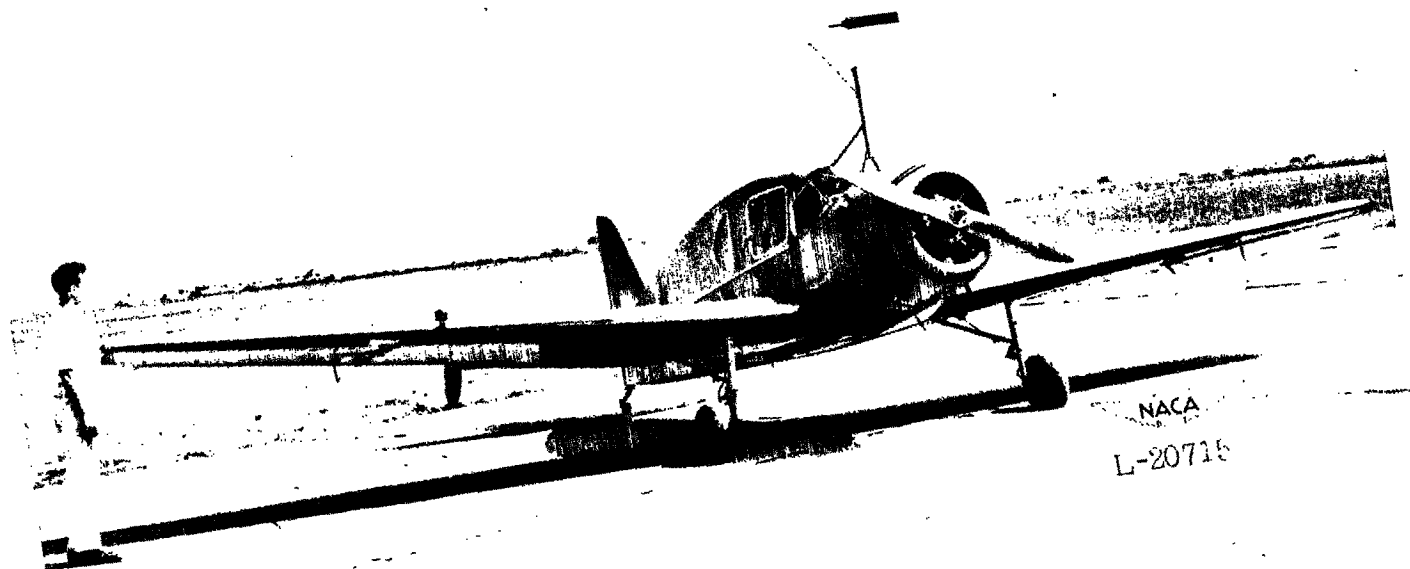
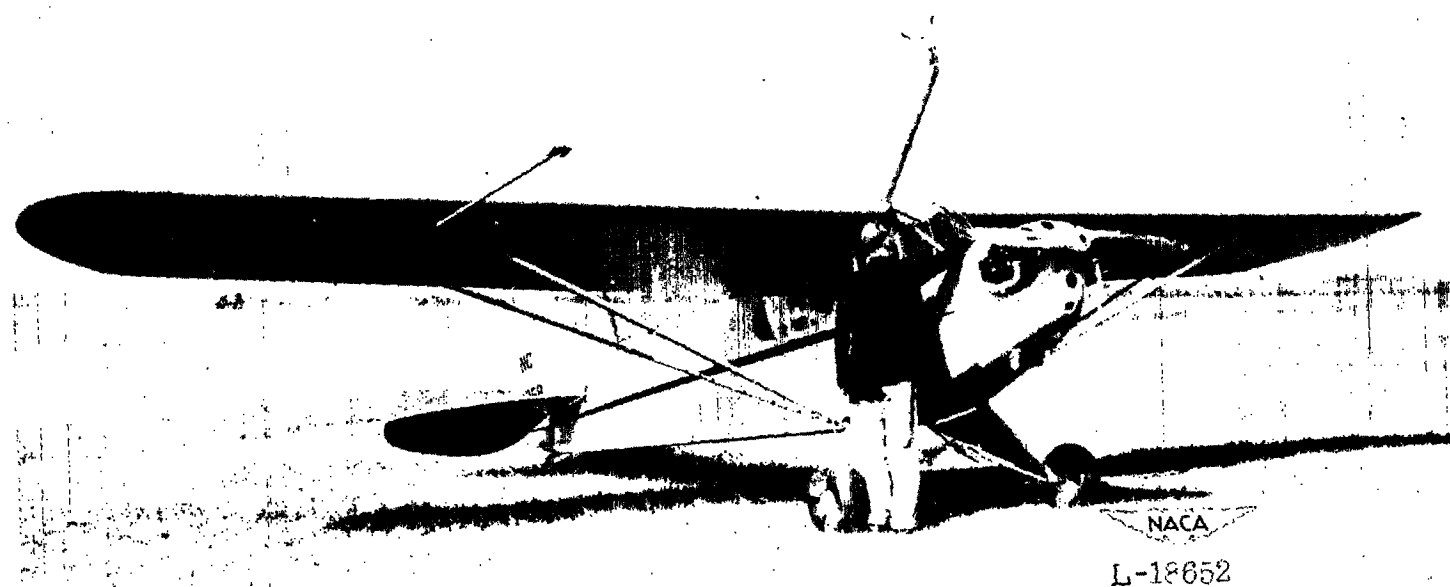
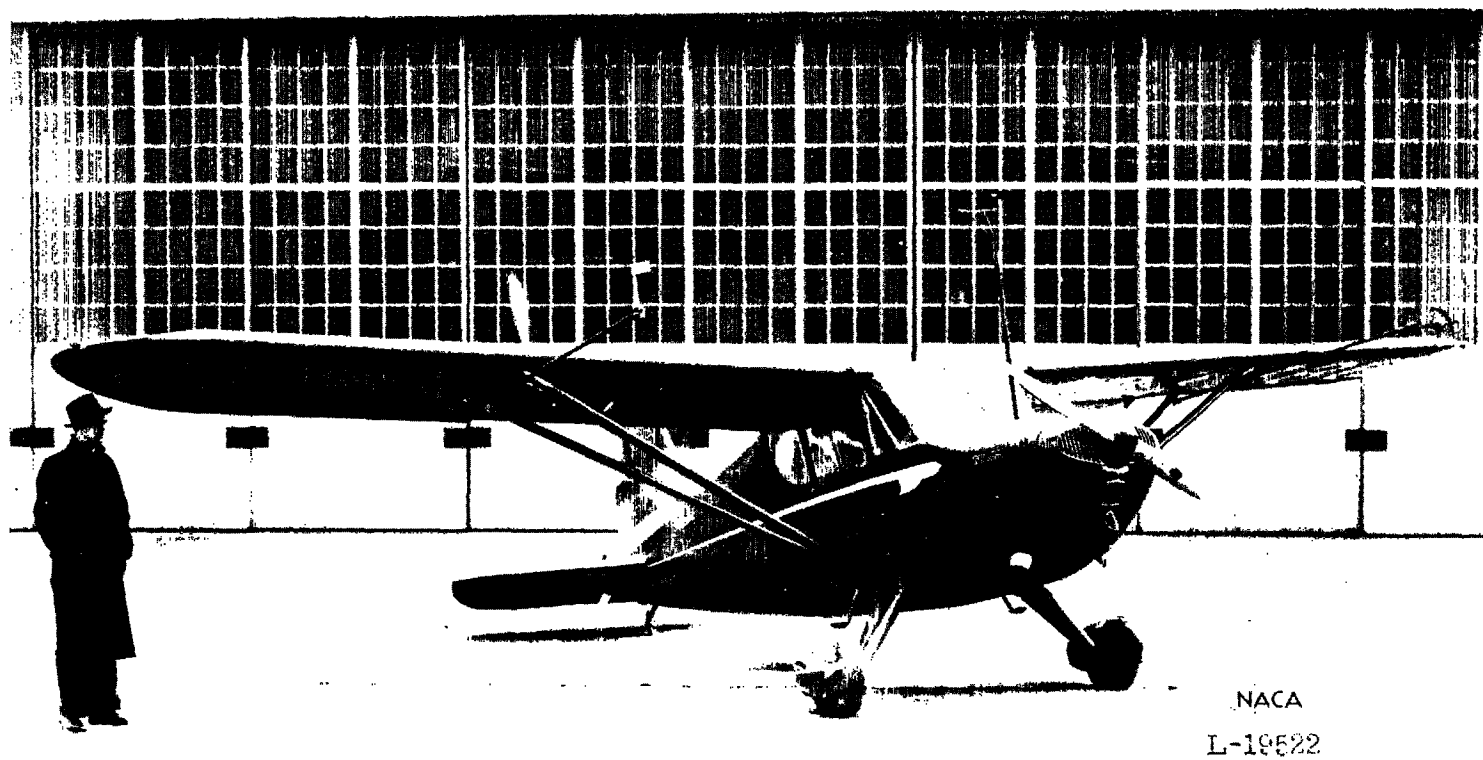
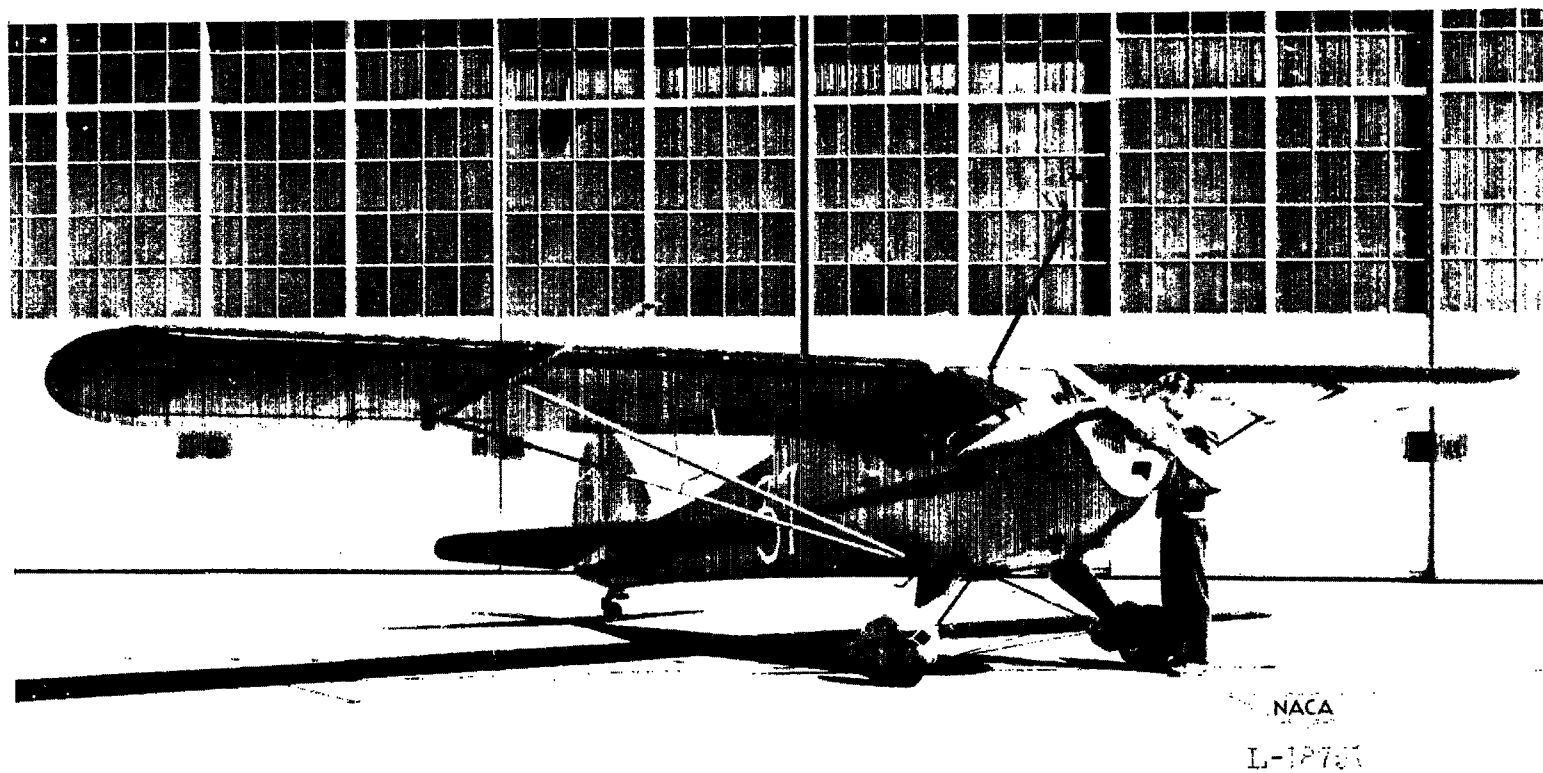
Figure 1.- Three-quarter front views of airplanes tested.

Descriptive characteristics of the five light airplanes are given in table I. Photographs of the five light airplanes are shown as figure 1 and three-view drawings are shown in figure 2. All five airplanes were two-place or three-place cabin land monoplanes and, except for airplane 2, all had fixed landing gears. Airplane 4 was the only one that had wing flaps and/or slots. The control-surface gaps were unsealed, except in the case of the rudder and elevator of airplane 2. The longitudinal trimming device consisted of an elevator trim tab for airplanes 1, 2, and 4; an adjustable stabilizer for airplane 3; and an independent airfoil mounted below the horizontal tail for airplane 5.

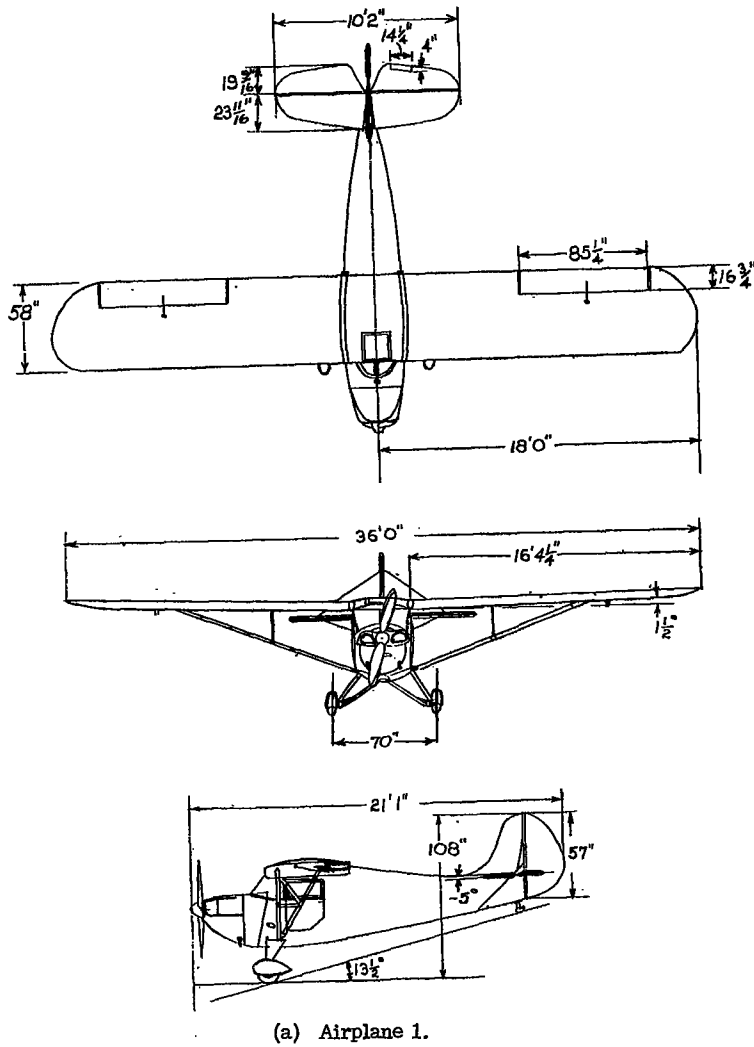
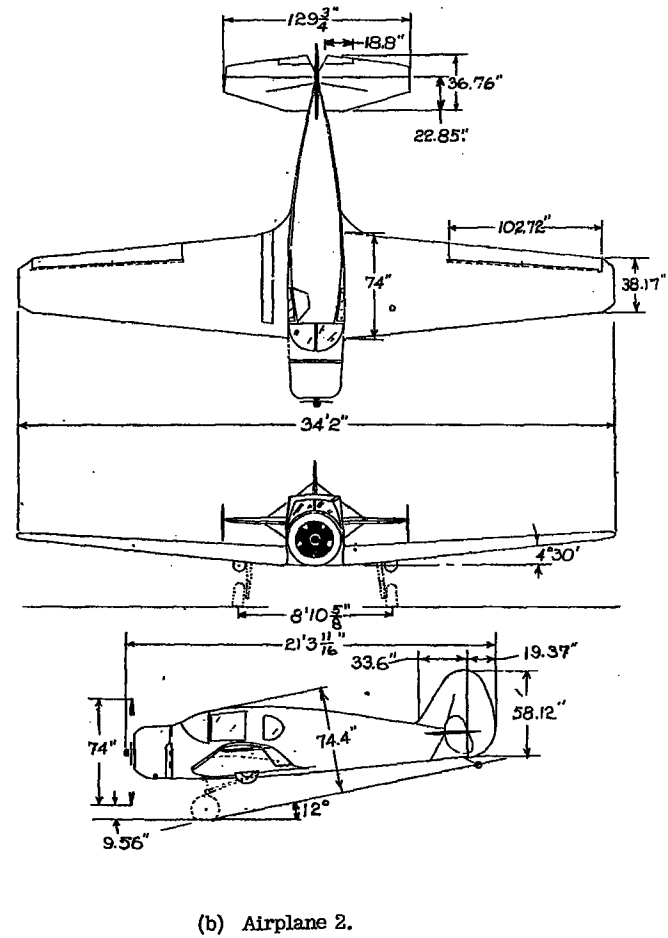
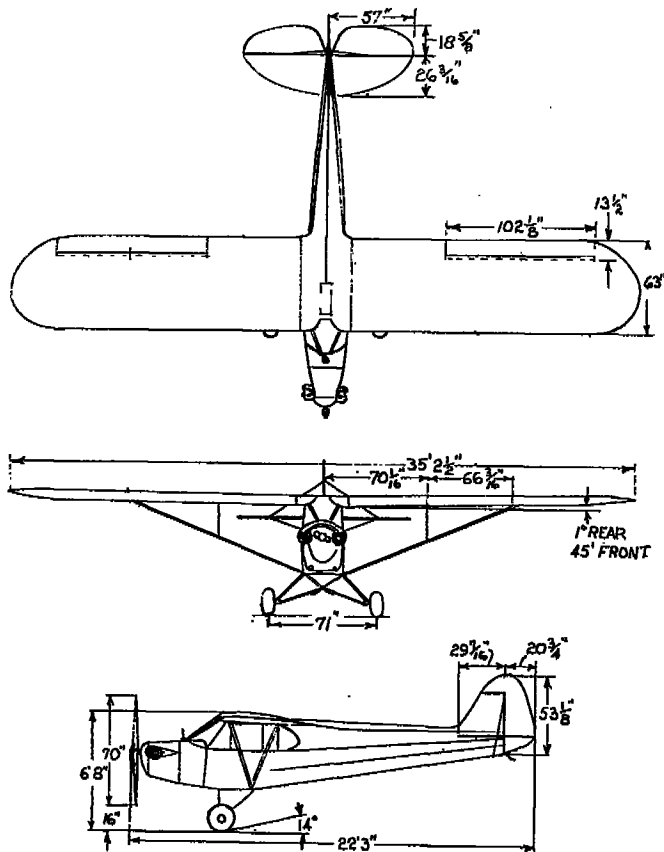
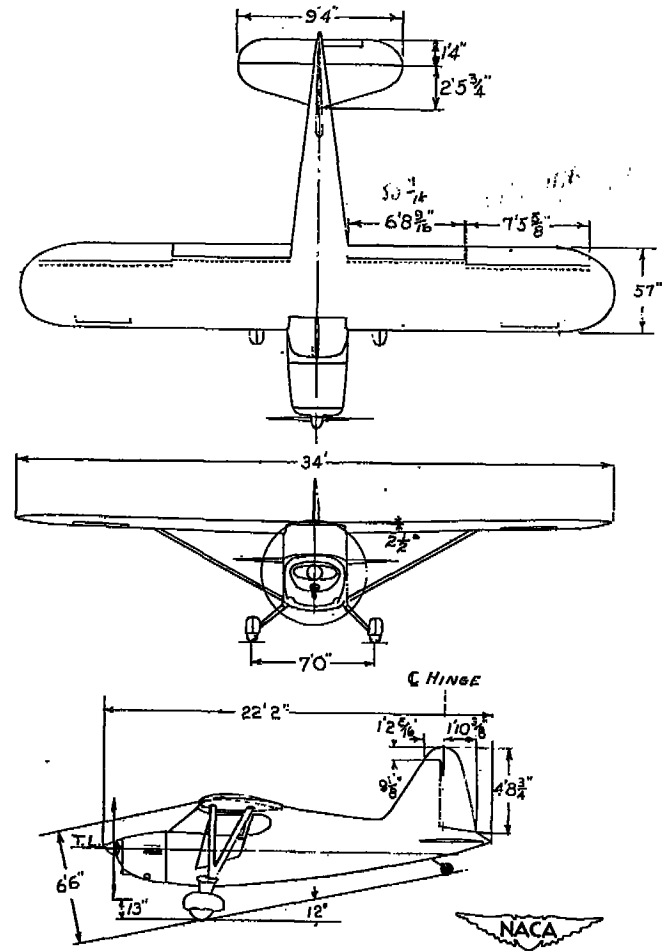
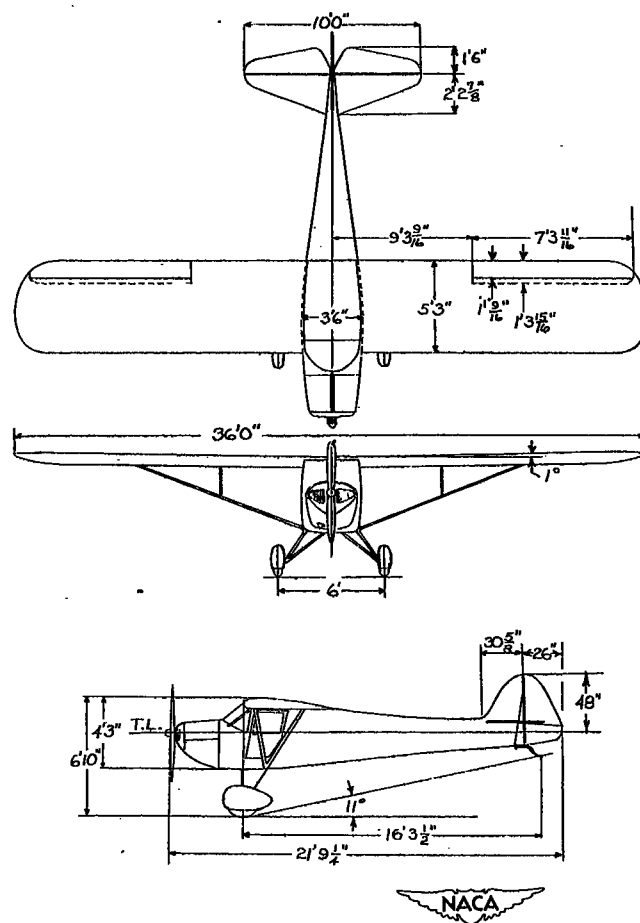
Figure 2.- Three-view drawings of airplanes.

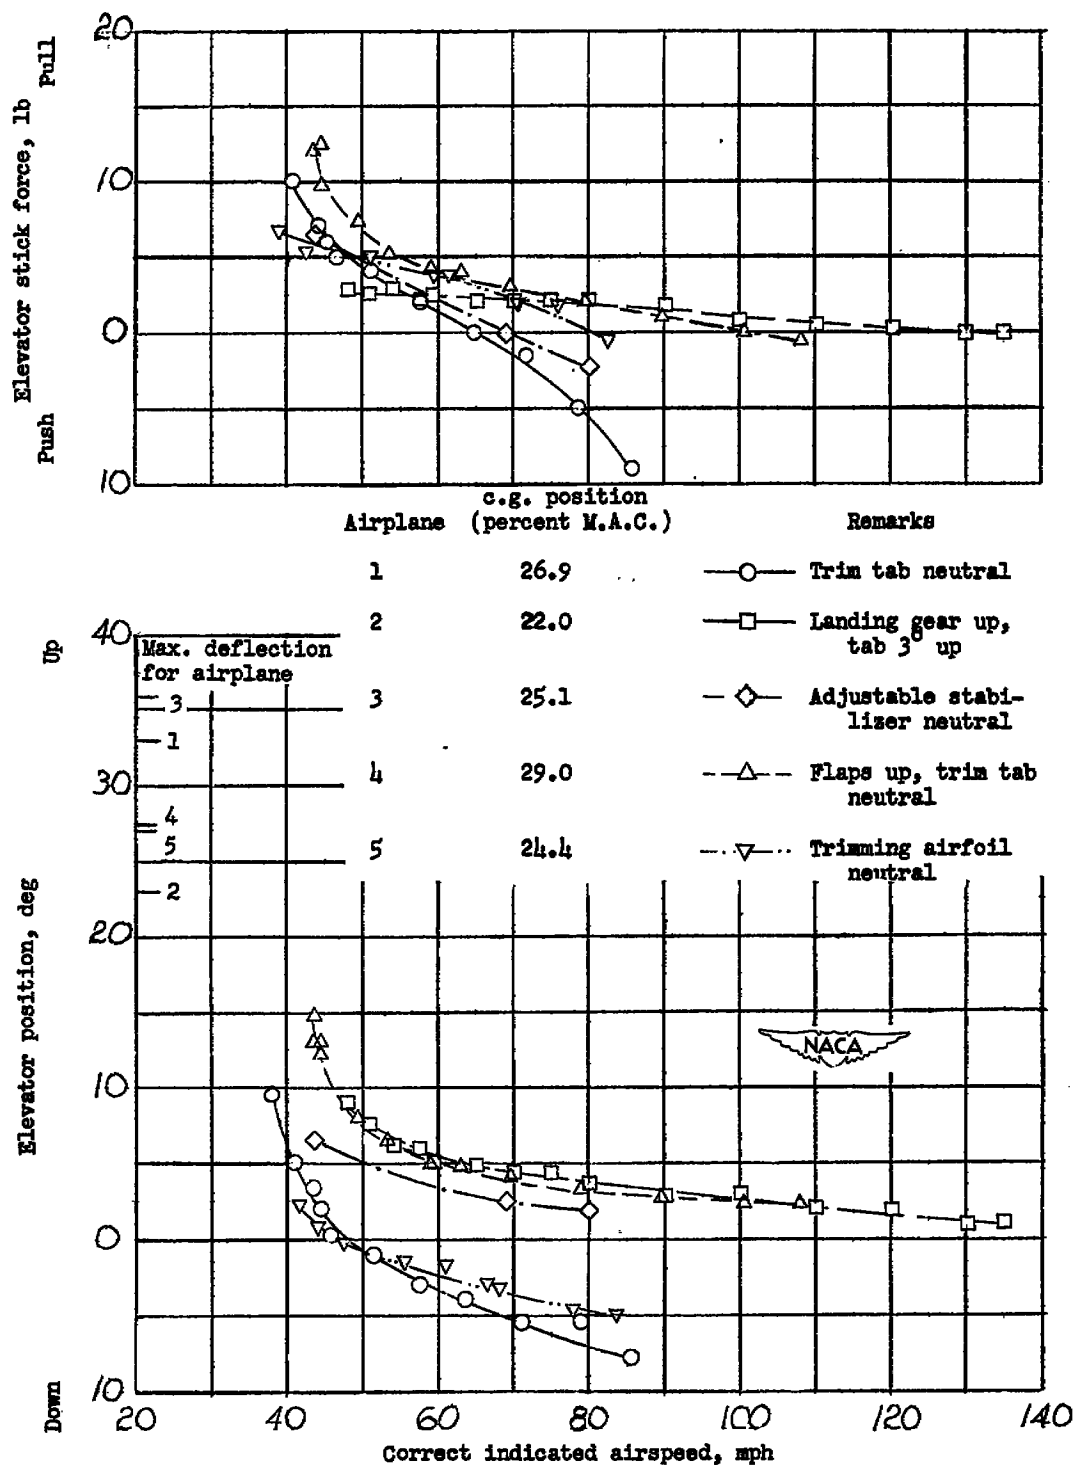
Figure 3.- Static longitudinal stability characteristics. Power-on cruising; airplanes 1, 2, 3, 4, and 5.

Static longitudinal stability.— The static longitudinal stability characteristics of the five light airplanes for the power-on cruising condition at a center-of-gravity position in the middle of the allowable range are shown in figure 3. The trim devices were set at neutral for four of the five airplanes. No data on airplane 2 with tab neutral were available; therefore data with the airplane trimmed full nose heavy (tab 3° up) were used. It is not believed that this tab deflection would cause much variation in elevator angle and stick force from those with neutral tab position. This condition was chosen because it is the one in which the most flying time is spent and is the one for which the most comparable data were available. The variation of elevator angle with airspeed, shown in the lower part of figure 3, is an indication of the so-called stick-fixed static longitudinal stability and provides an indication of the stability in terms of the pilot's feel of stick position. Positive stick-fixed stability insures that the airplane will tend to return to a given angle of attack or airspeed following a disturbance. The five light airplanes tested were statically stable, longitudinally, with stick fixed and power on, as shown by the negative slope of the curve of elevator position against airspeed, although the degree of stability varied

The stick-free static longitudinal stability characteristics in the power-on cruising condition are shown by the curves of elevator stick force plotted against airspeed in the upper part of figure 3. The variation of elevator stick force with airspeed is an important criterion of the pilot's control "feel." The curves show that all five airplanes were statically stable, longitudinally, with stick free and power on and that the forces were small compared to the pilot's physical capabilities.

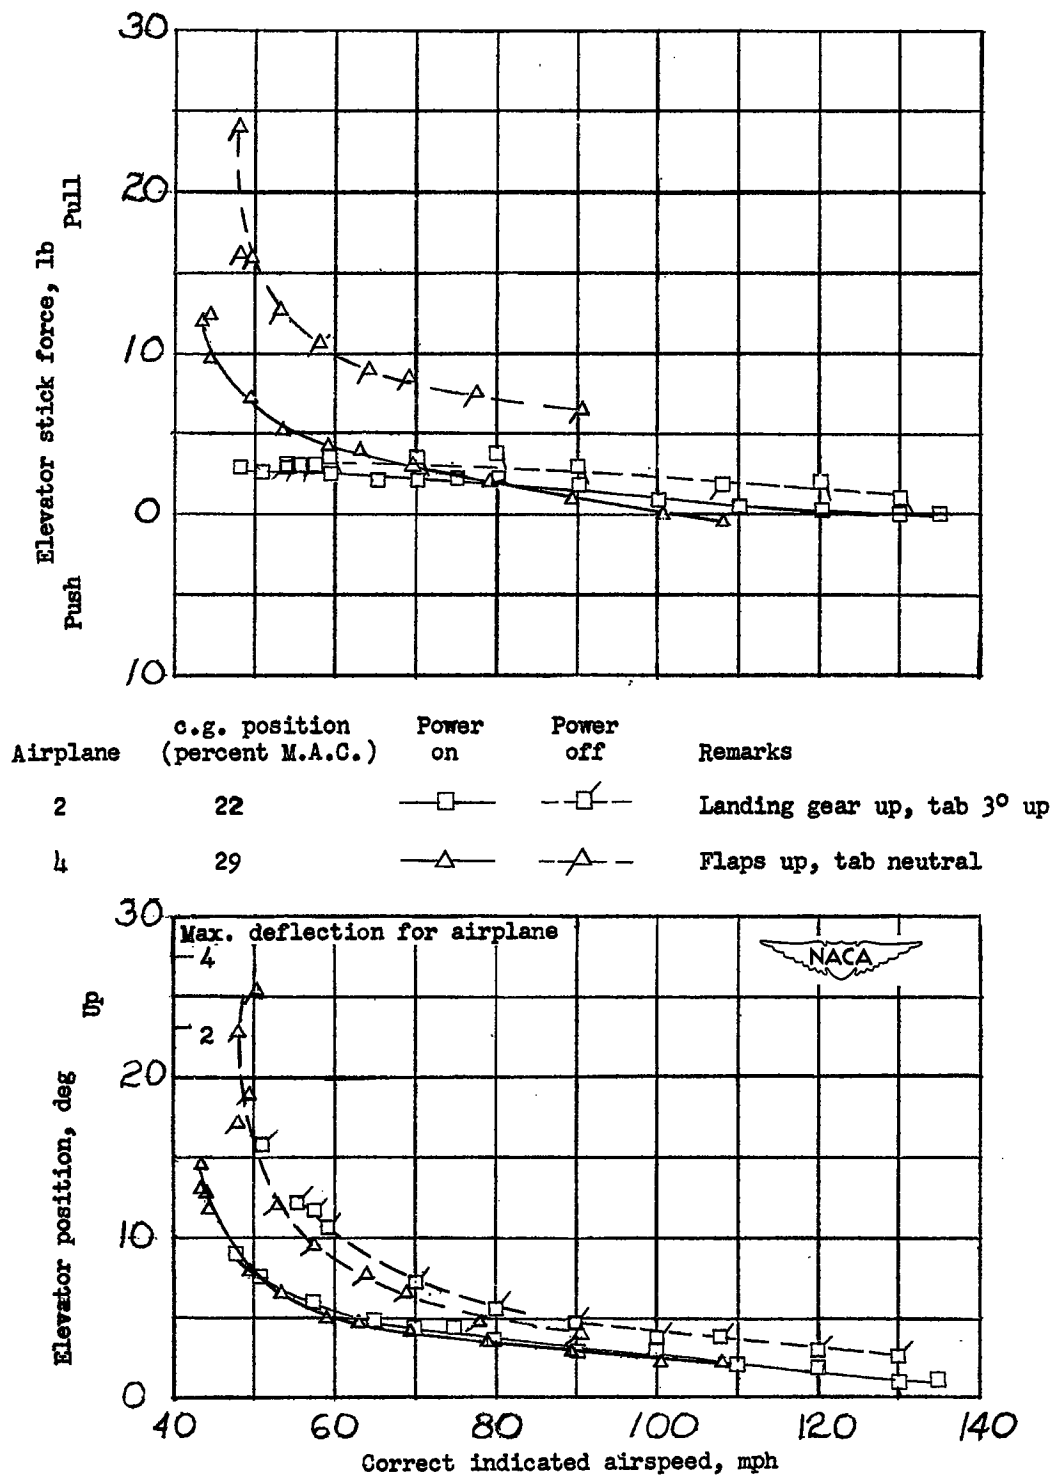
Figure 4.- Effect of engine power on static longitudinal stability characteristics. Airplanes 2 and 4.

the steeper slope of the curve of elevator angle against airspeed. This effect was the same for all five airplanes tested. The increased pull forces required to trim at a given airspeed with power off may be seen from the curves of figure 4 for both airplanes although the force changes are greater for airplane 4. Had the airplanes been trimmed at the same airspeed for the power-off condition as for the power-on condition, the slopes of the power-off curves would have been increased and would indicate an increase in stick-free static longitudinal stability.

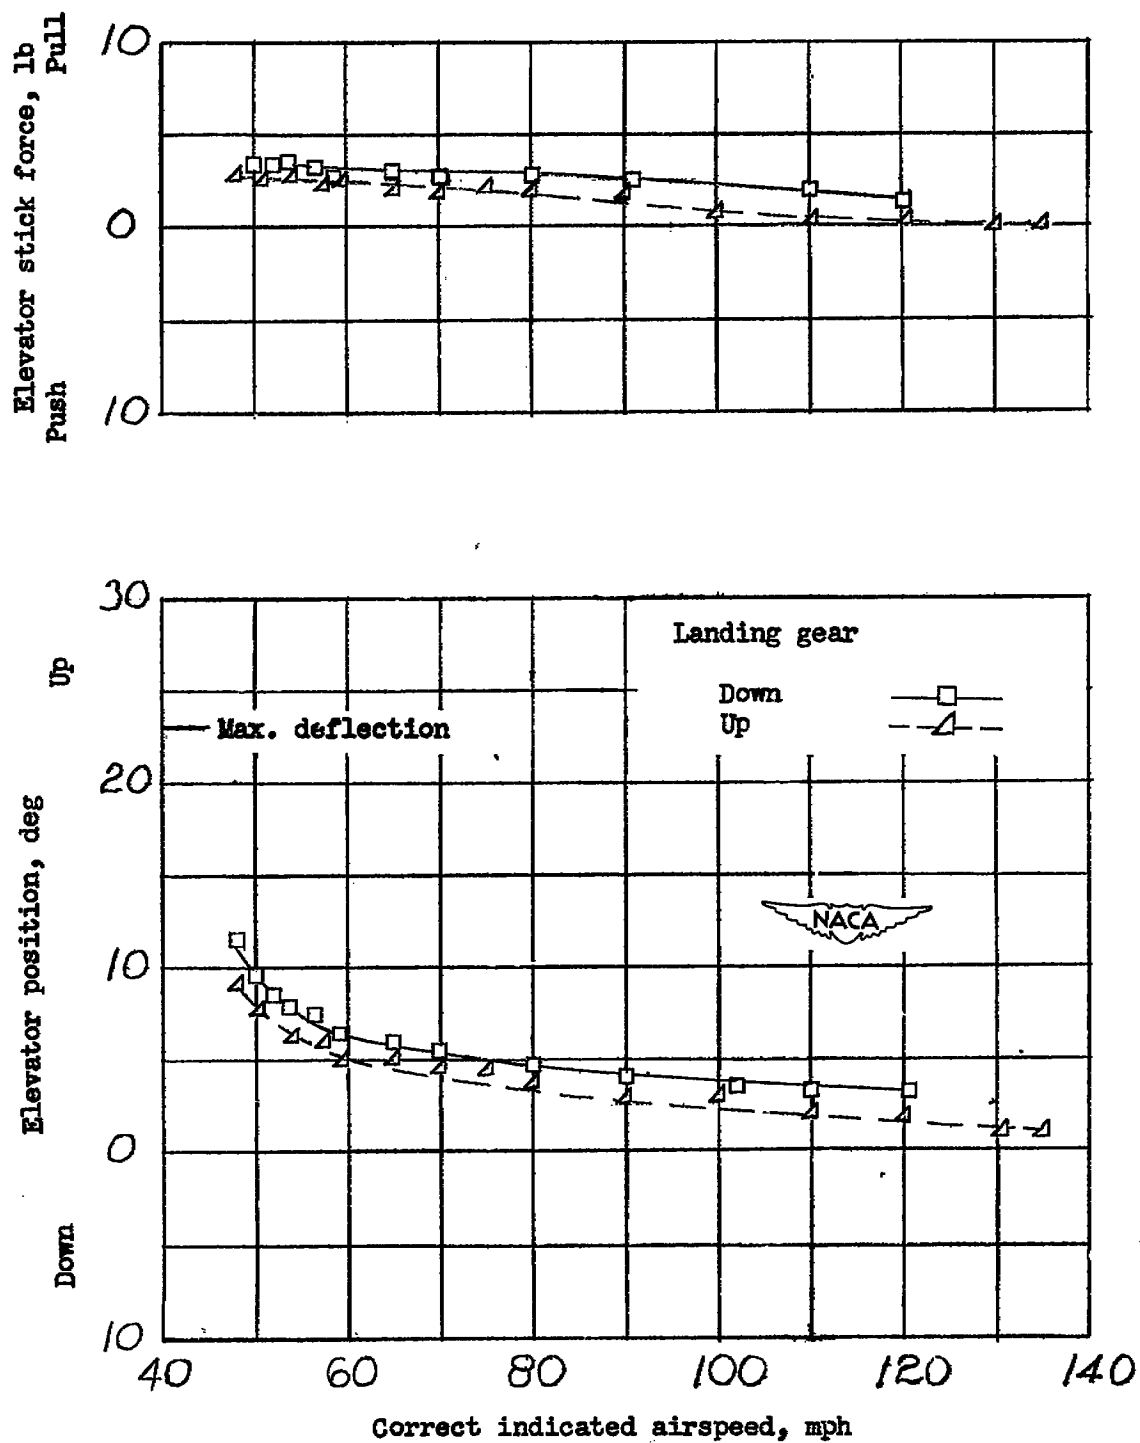
Figure 5.- Effect of landing gear on static longitudinal stability characteristics. Center-of-gravity position, 22 percent M.A.C.; trim tab 3° up; power on; airplane 2.

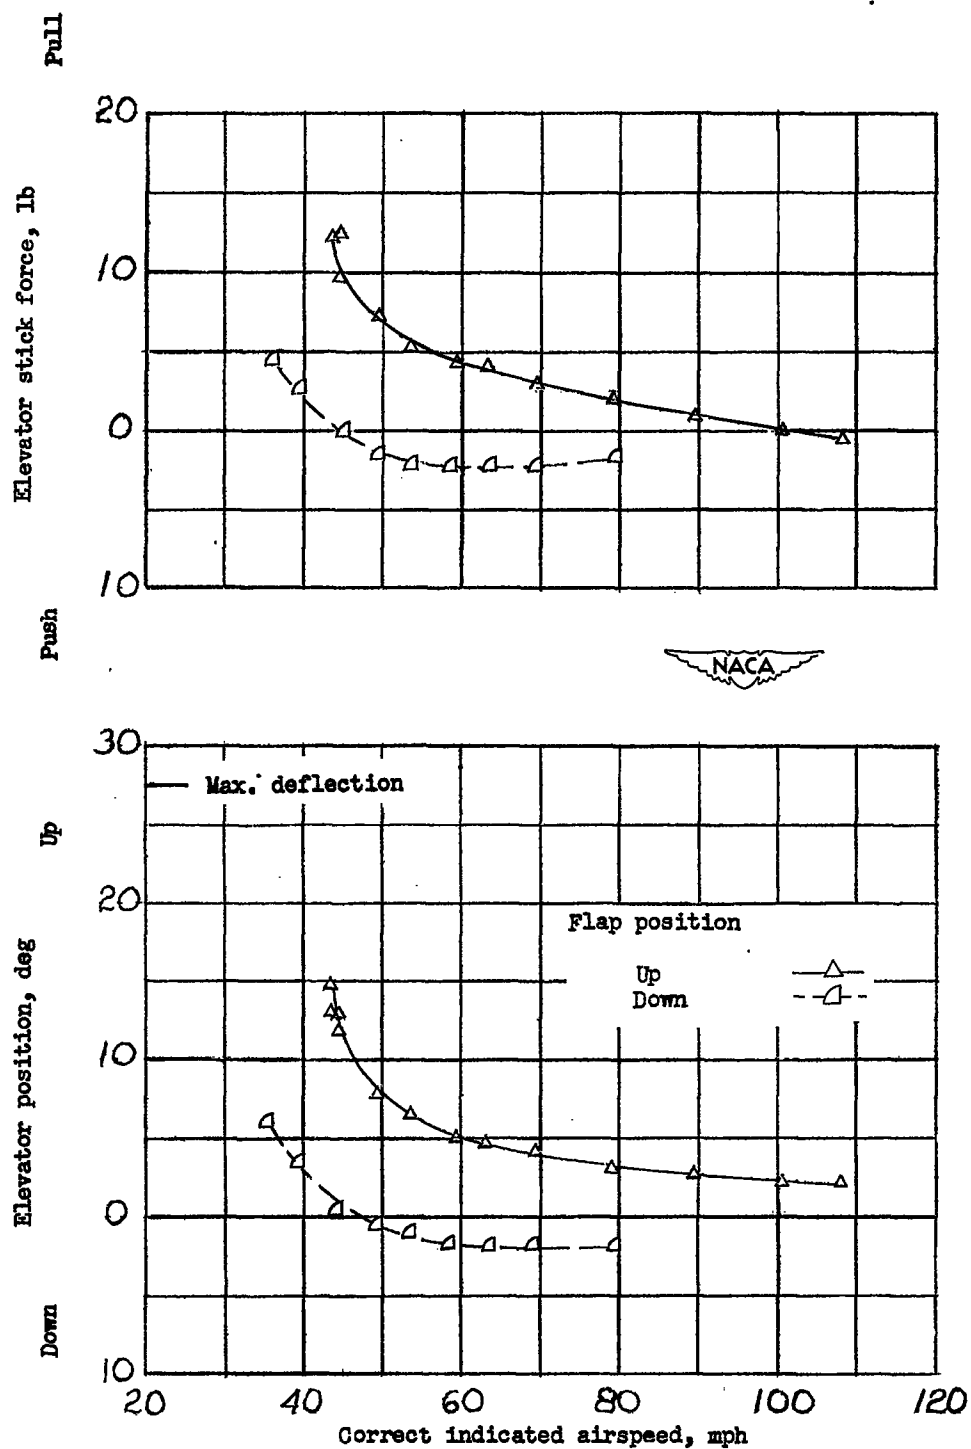
Figure 6.- Effect of flaps on static longitudinal stability characteristics with power on. Center-of-gravity position, 29 percent M.A.C.; trim tab neutral; airplane 4.

The effect of flaps on the static longitudinal stability of airplane 4 is shown in figure 6. Deflecting the flaps caused a decrease in stability, both stick-fixed and stick-free, and also reduced the up-elevator angles and pull forces required to trim at various airspeeds throughout the speed range. These effects were probably caused by a change in downwash over the horizontal tail and/or a change in dynamic pressure at the tail with flaps down. Notice the slight stick-free instability and stick-fixed neutral stability which occurs in the power-on flaps-down condition at speeds above 60 miles per hour. This condition was the only one in which negative stability was found to exist for any of the airplanes tested.

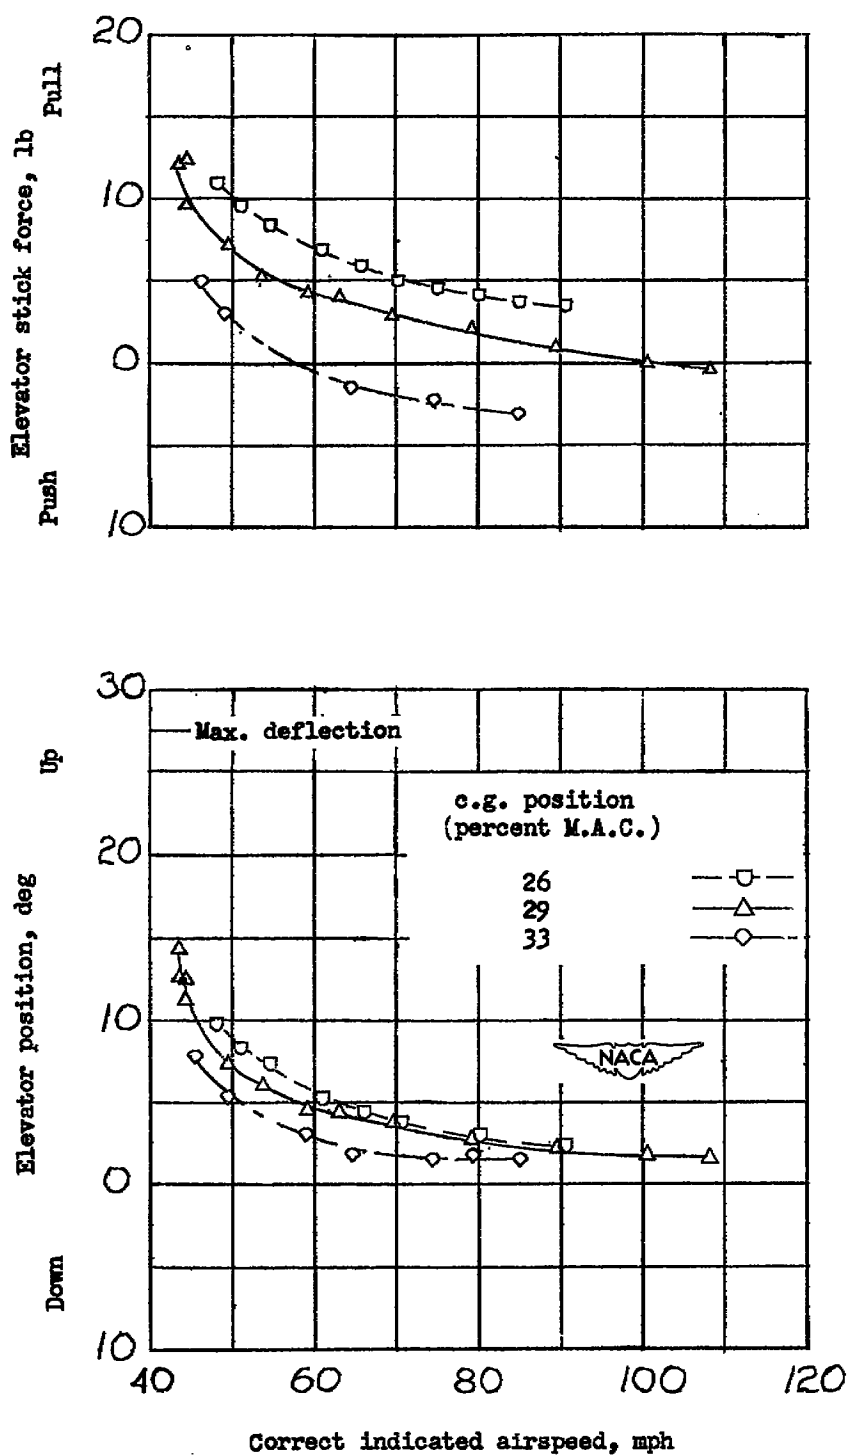
Figure 7.- Effect of center-of-gravity position on static longitudinal stability. Trim tab neutral; power on; flaps up; airplane 4.

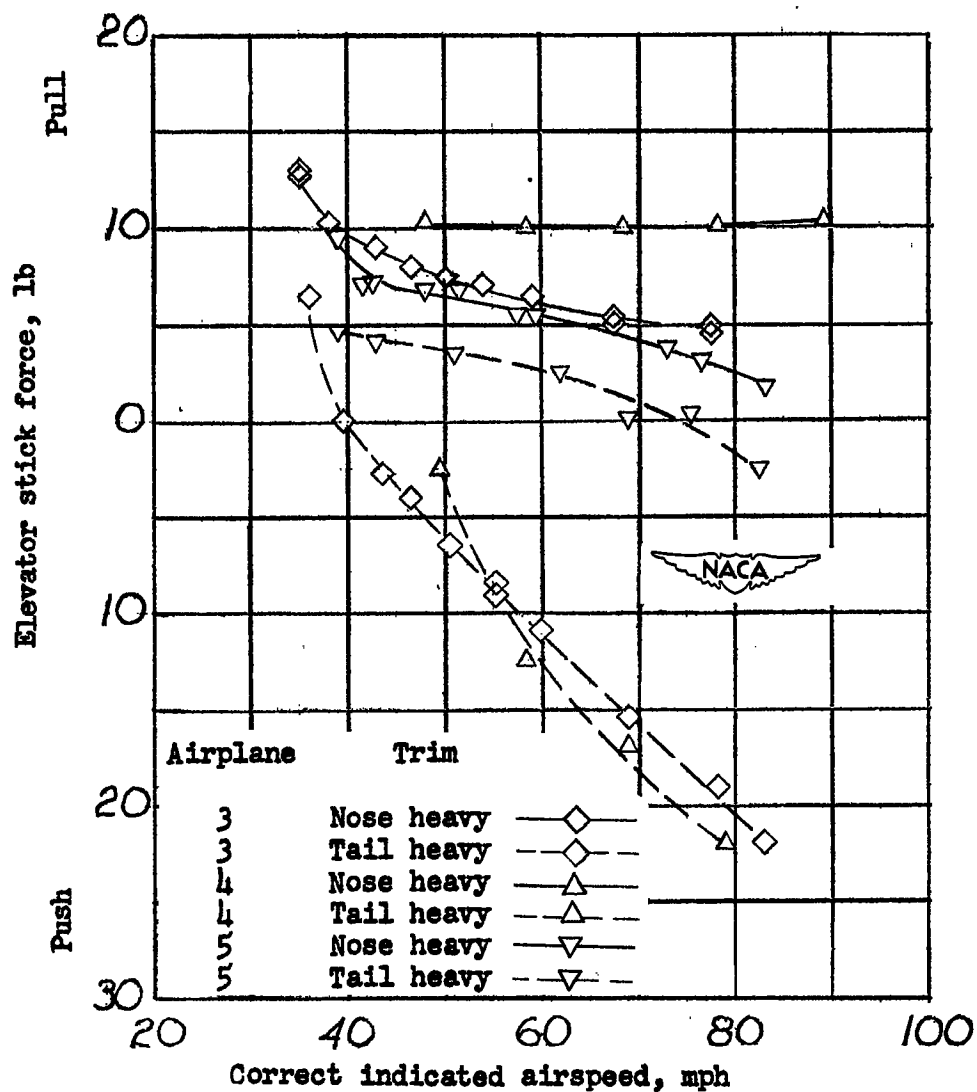
Figure 8.- Effect of trim-device setting on the variation of elevator stick force with speed. Power on; airplanes 3, 4, and 5.

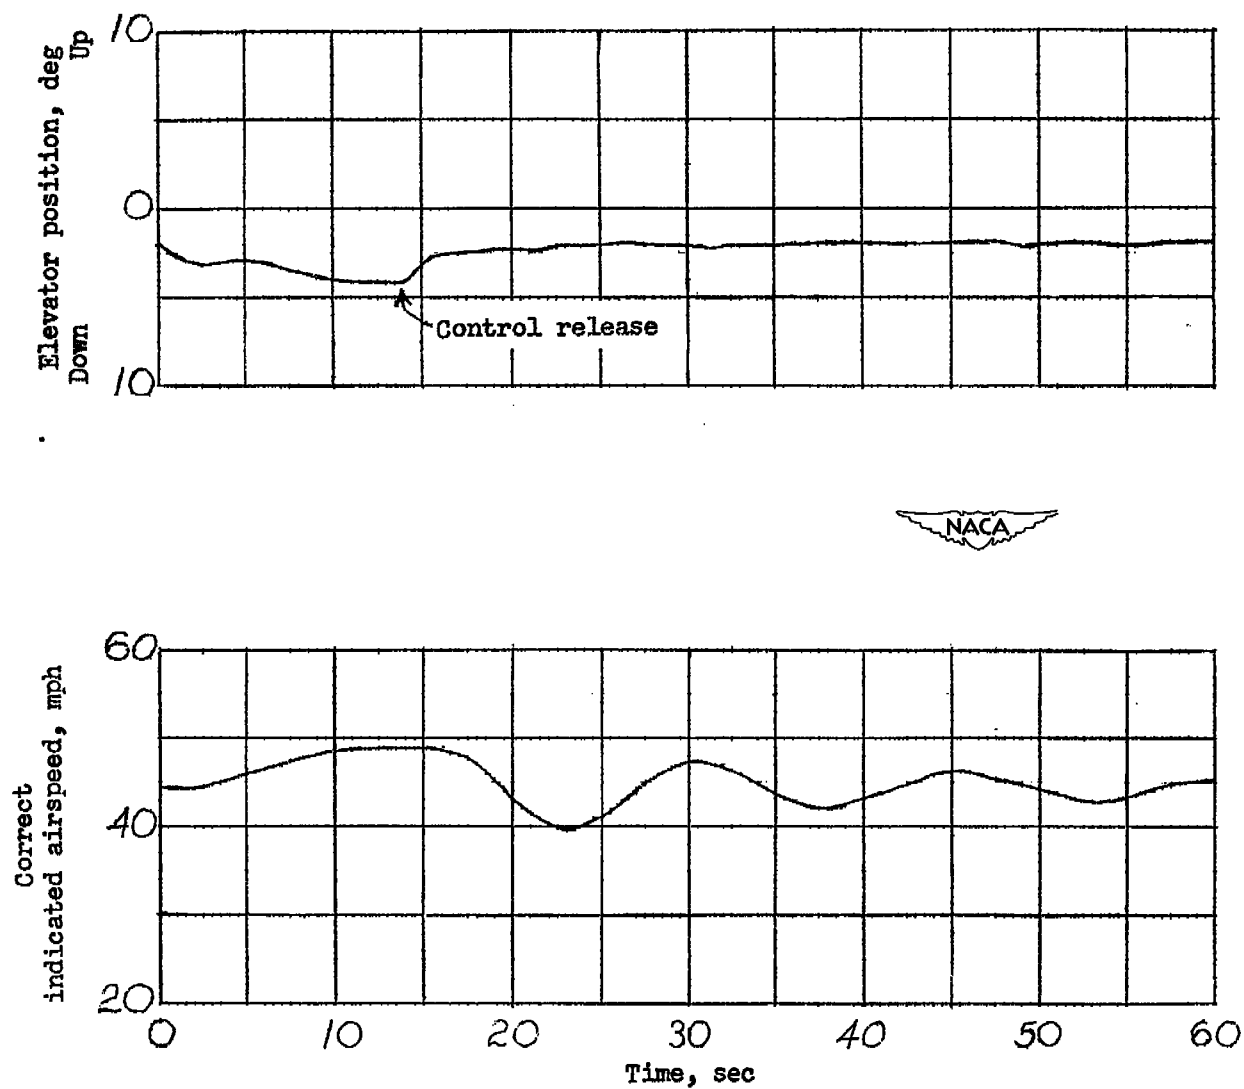
Figure 9.- Time history of a typical longitudinal oscillation. Flaps up; power on; rearward center-of-gravity position; airplane 4.

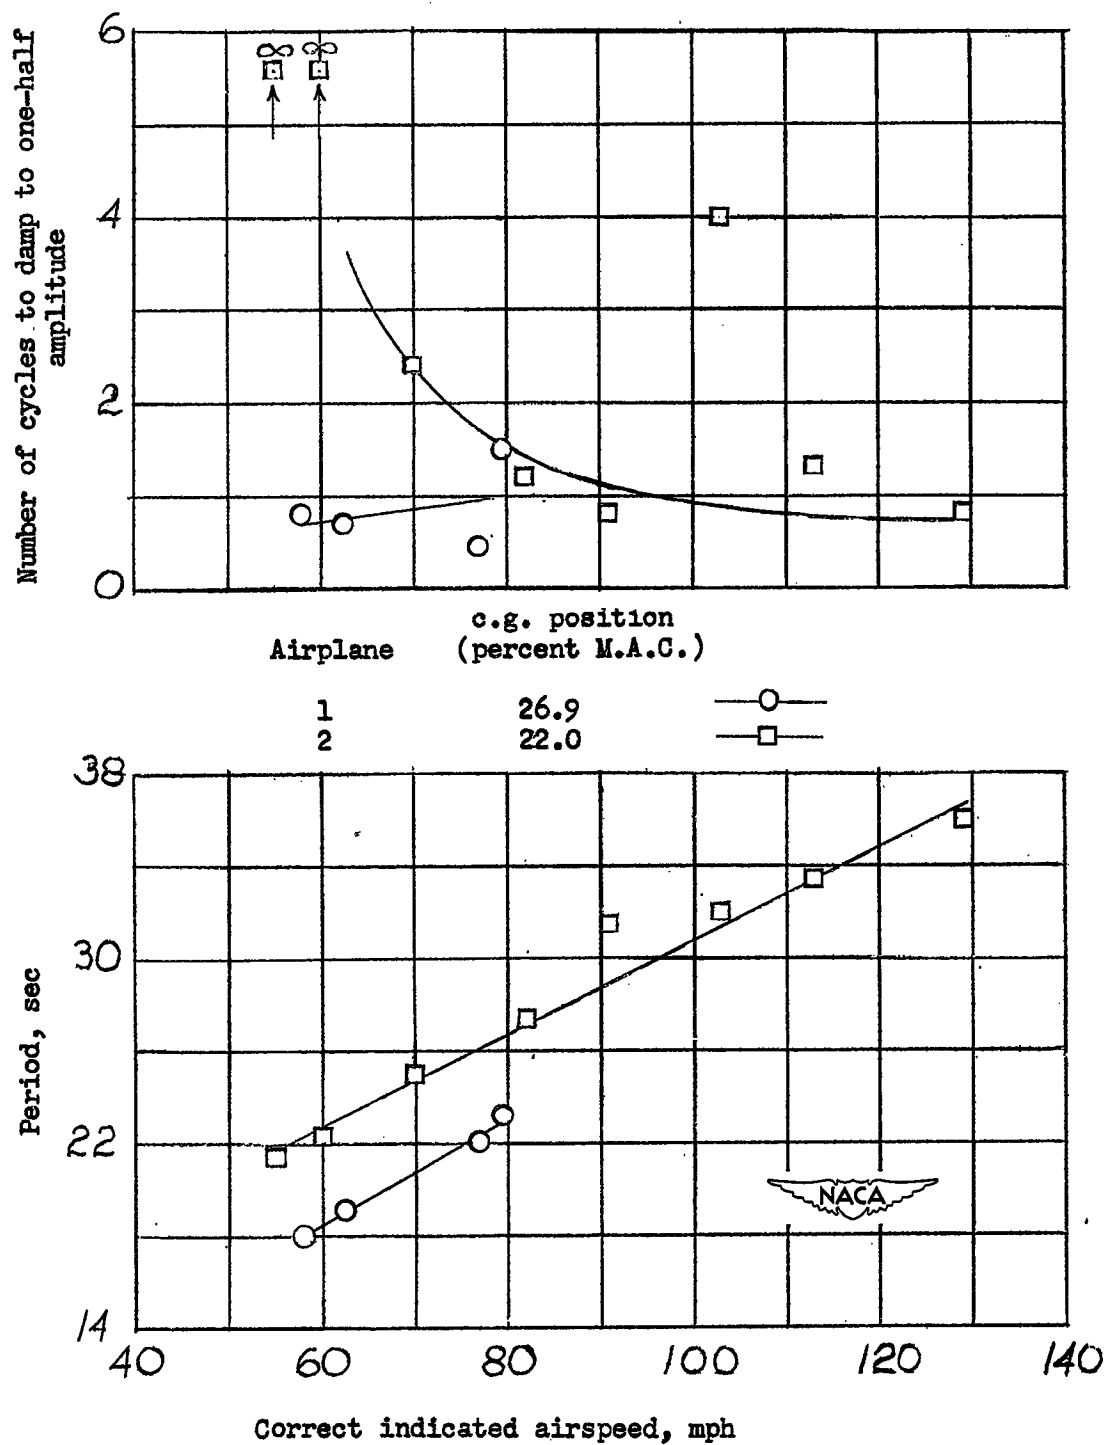
Figure 10.- Period and damping characteristics of longitudinal oscillations. Power on; airplanes 1 and 2.

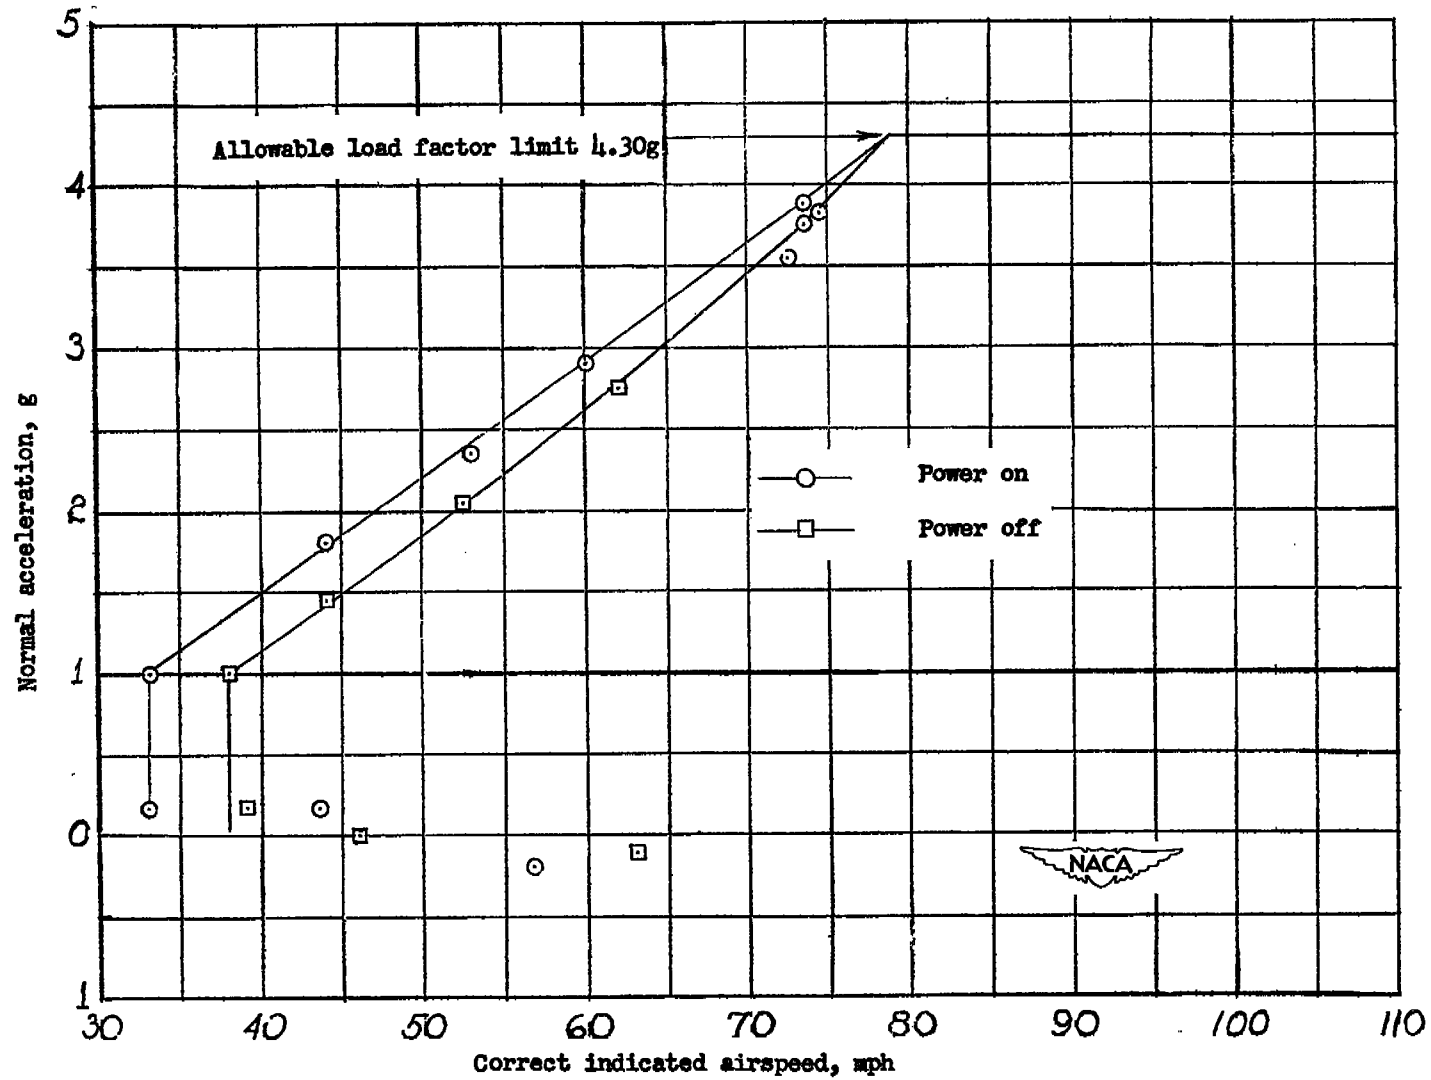
Figure 11.- Normal accelerations produced by abrupt pull-ups and push-downs from level flight with power on and off using full elevator control. Airplane 3.
